STRUCTURES TEST REPORT

ST11498-001-01

PURLIN SCREW TESTING FOR BUILDING KING

Building King Limited
1/126 Cuba Street
Te Aro
Wellington 6011

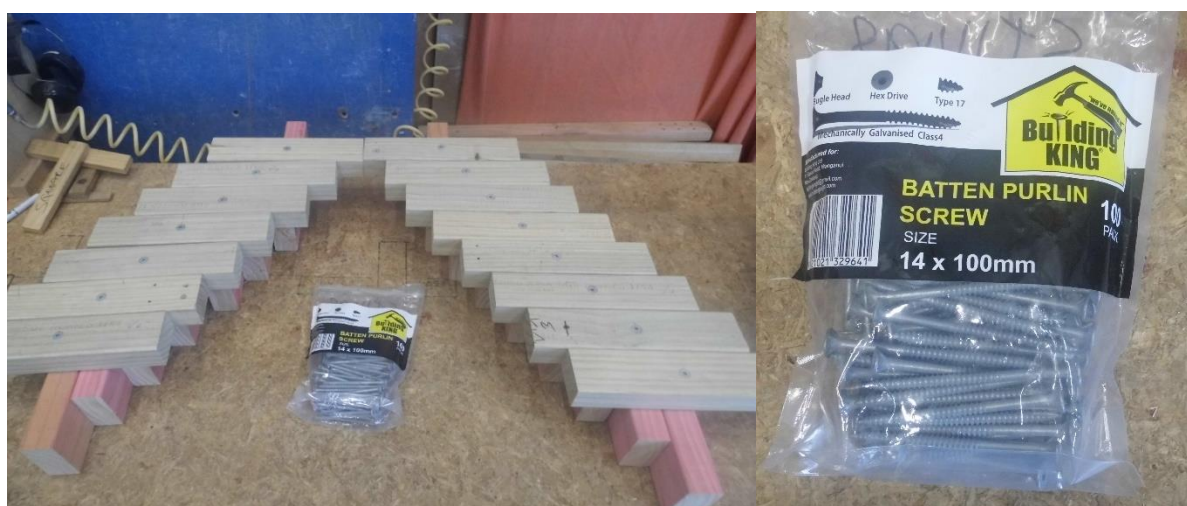
Figure 1. Typical Batten-to-Purlin Connection Specimens and Screw Packaging (Right)

Thirty specimens were constructed by BRANZ technical staff where the provided screws were used to connect 300 mm long sections of 45 mm x 70 mm battens to 300 mm long sections of 90 mm x 45 mm SG8 Radiata Pine timber. Typical test specimens are shown in Figure 1 along with provided screws and packaging.

The client provided 14-gauge x 100 mm long batten screws with a Type 17 self-drilling tip. These screws had a recessed hex drive and bugle head with an approximate diameter of 14 mm and outer thread diameter of approximately 6.4 mm.

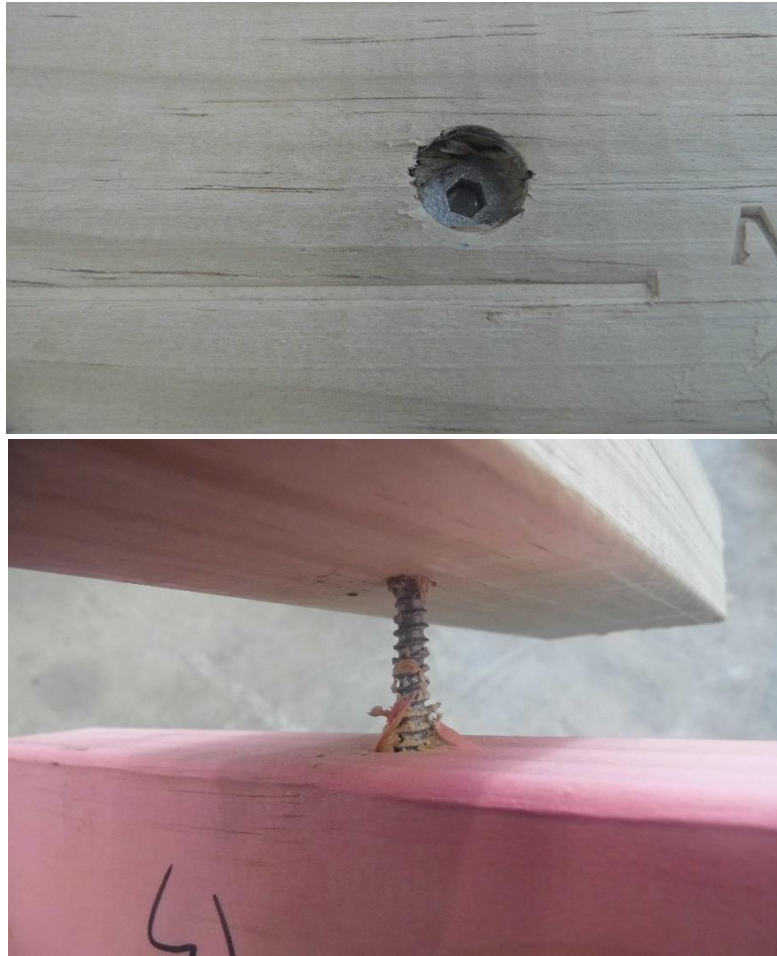
Figure 3. Examples of Screw Failures: Screw-Head Pulling Through Batten (Top) and Screw Thread Withdrawal from Purlin (Bottom)

Specimens failed due to a combination of the screw heads pulling through the battens and the screw threads withdrawing from the purlins, as shown in Figure 3. Some specimens were dominated by one or the other failure mode while others exhibited a combination of both.
